### Internal Wire Harness

• GM 4L60-E • 2003-Later

PART # 350-0061

#### Installation & Assembly

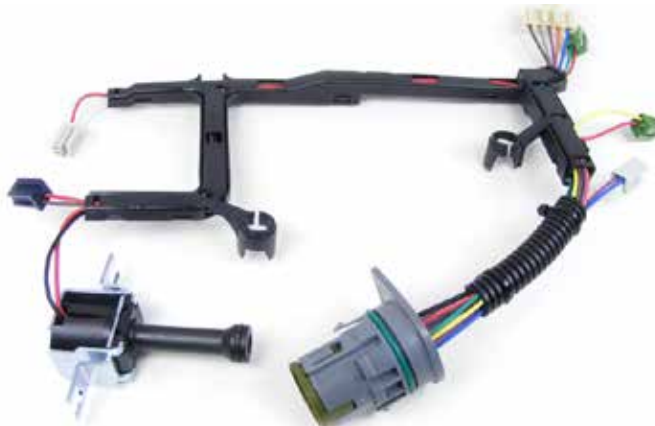
#### GM 4L60-E 2003-Up Valve Body

- Remove old wire harness from valve body.
- Install new Rostra wire harness.  
**NOTE:** Bolt locations may differ from old harness.
- Plug-in connectors as shown in figure below.

**CAUTION:** Care must be taken when reinstalling pan to prevent pinching wires.
